CUMMINS CYLINDER HEAD STUDS AND O-RINGS FOR MAXIMUM RELIABILITY

RUST BUCKET'S WEAK LINK

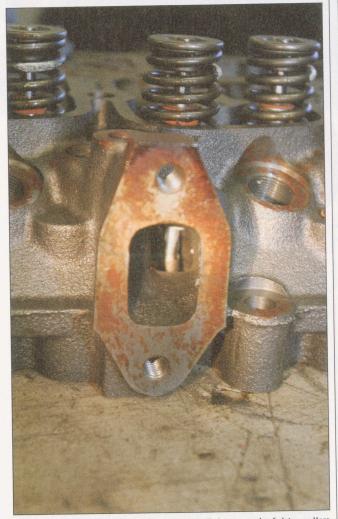
It's hard to describe a \$450 port job in words, so we'll show a couple of pictures. Here is a stock exhaust port of a stock 5.9L Cummins head.

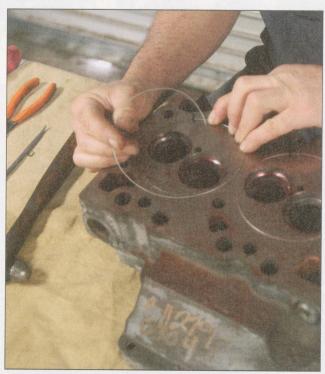
After our head was ported, it was then cut for O-rings. The O-ringing process involves cutting a groove into the surface of the head and installing a thin stainless steel wire ring around where the head seals to the deck of the block. This is very meticulous work and requires very precise measuring and a steady hand to perform.

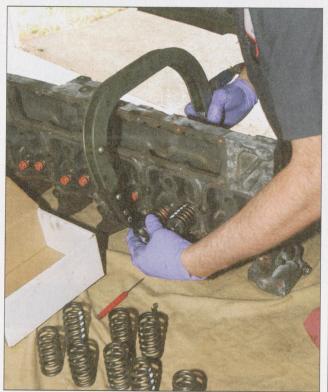
Brian Garbut, our O-ring guru, also installed a set of 60-pound valvesprings, which ensured no valve float would occur if our engine spun more than 3,200 rpm.

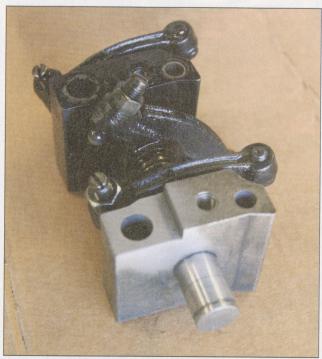
In order to install ARP studs, our rocker arm pedestals had to be machined down 0.200 inch. Any local machine shop should be able to perform this task. Our bill was \$100 from Arden's Machine in Redding, California.

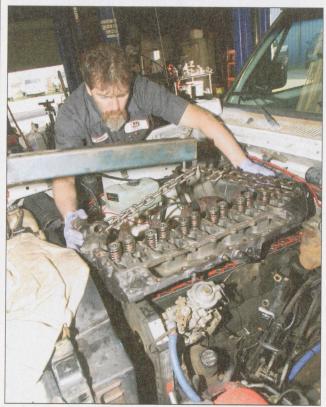
After the head was assembled and the O-rings were installed, the head was lowered onto two dowels in the block using two of the studs as guides. We used a head gasket that was 0.020 thicker than stock to give a little extra crush space for our O-ring setup.

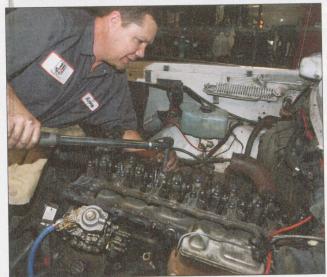
The next morning, when Harvey Grant of J&H Performance checked the studs, he found it only took about 113 ft-lb of force to loosen them up, so each nut was taken off one at a time and re-torqued to 125 ft-lb following the previously described increments.

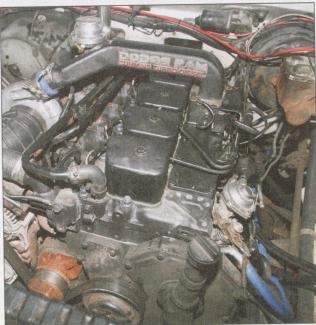
Even with everything installed, the project still wasn't finished. The truck was taken for a 20-minute testdrive to bring it up to operating temperature. Then the head studs were torqued a third time with the engine warm—this time to 140 ft-lb. Although this is past ARP's recommendation of 125 ft-lb, we wanted a little extra clamping force because of our O-ring setup and extra-thick head gasket. If you plan on going past 125 ft-lb, do so at your own risk. During the last re-torque, the feeler gauge would no longer fit between the rockers and valves, and measurements indicated our head had sunk down about another 0.005 inch. After two cold re-torques and one hot one, we were finally ready to hit the road.
