CUMMINS CYLINDER HEAD STUDS AND O-RINGS FOR MAXIMUM RELIABILITY

RUST BUCKET'S WEAK LINK

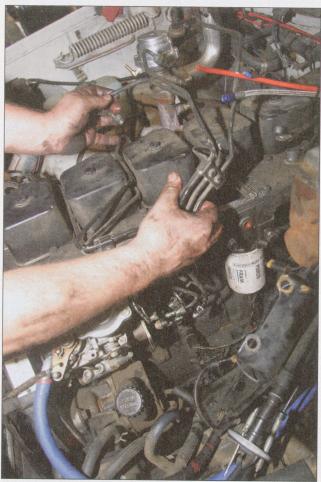
Before the Cummins cylinder head can be removed, everything else on top of it must be taken off. This means the intake horn, throttle linkage, coolant lines, and injector lines. When removing the injection lines, make sure to take them off at the pump and remove them in two pairs of three, otherwise they'll end up like spaghetti when you try to re-install them.
